NEW LOUNT COLLIERY HERITAGE TRAIL

UNDERGROUND ACTIVITIES

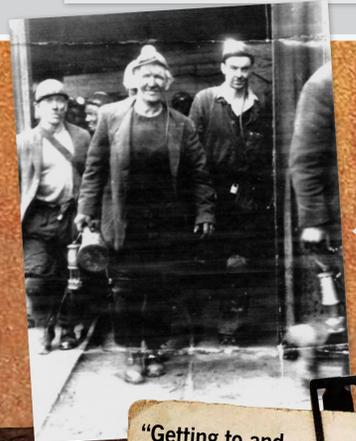
"Getting to and from the coal face"
This photograph shows miners reaching the surface at the end of their shift. Some can be seen carrying safety lamps.

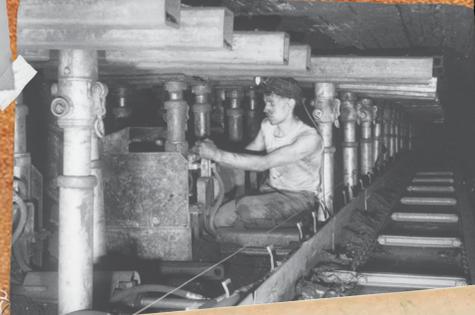
"Supports at Coal Face"
This photograph shows power supports (hydraulic chocks) being moved forward along a coal face with the panzer conveyor positioned in front of the supports. Moving these supports was a specialist job within the coal face team – "a Chocker".

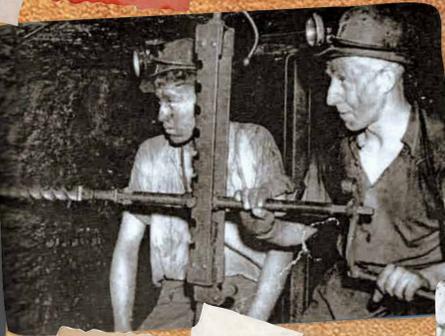
Hand Drilling of Holes.
This photograph shows a father and son team hand drilling holes across the face for future blasting. These hand drills were replaced by electric drills once power was installed underground.

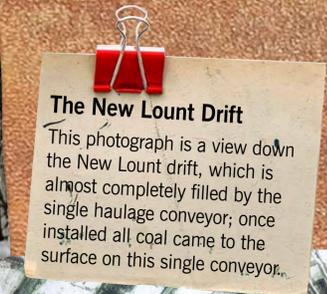
The New Lount Drift
This photograph is a view down the New Lount drift, which is almost completely filled by the single haulage conveyor; once installed all coal came to the surface on this single conveyor.

There was an increasing use of mechanisation and conveyors throughout the life of the colliery and with the introduction of the main drift in 1955 all coal was eventually conveyed from the coal faces to the surface by a system of haulage conveyors.

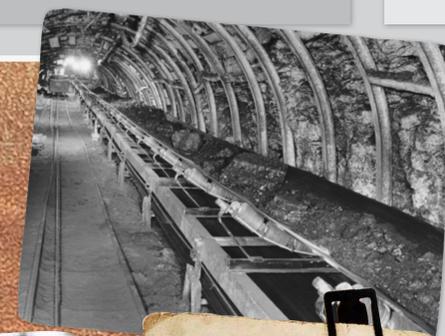
The Main Roadway taken 1963 showing continuous haulage of coal and tub tracks used to move materials underground.
